## **Reflective Cracking Construction Notes**

Date: December 12, 2014

**Project:** Reflective Cracking Indoor Phase IV

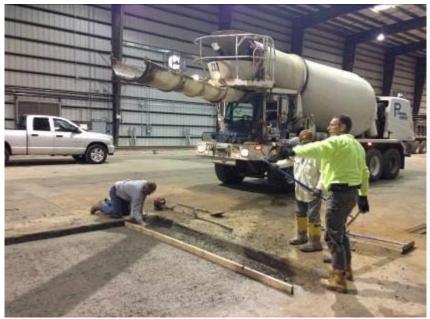
(a) Pouring Concrete Lead Slab.

United Concrete poured concrete for the new lead-in slab to the West of the test rig, as shown below in Figure 1, in the morning. Penn Jersey truck number 233 arrived at the NAPTF at approximately 9:00 am with a load of 4,000 psi concrete. The approximately 9-inch thick slab was finished using hand tools and provided with a broom-finished surface. At the request of SRA/FAA, United used a grooving tool to create a transverse contraction joint down the middle of the slab while the concrete was still fresh, shown in Figure (c. The slab was covered with concrete curing blankets upon completion.

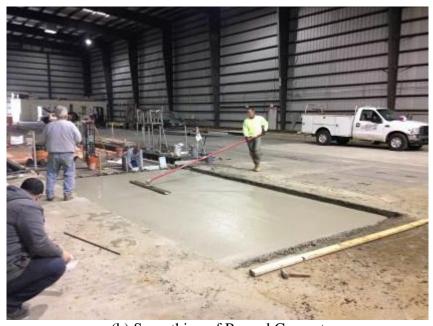
(b) Smoothing of Poured Concrete.

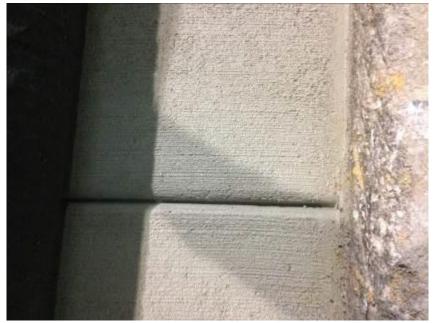
(c) Installed Joint.

Figure 1. Concrete Pouring of New Lead Slab West of Test Rig.

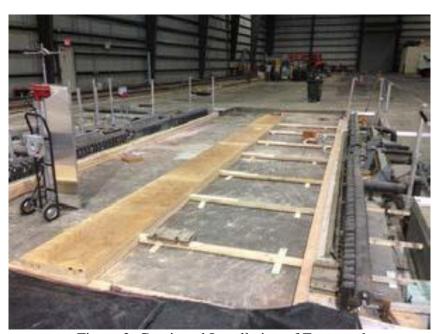
Figure 2. Continued Installation of Formwork.

SRA technicians obtained (3) cylinder samples of the concrete for compressive strength testing. United also continued the formwork installation, as shown below in Figure 2, for the Phase IV paving and applied additional Rapid Set Cement All® repair cement to the concrete surface of the test rig extending at least 6 inches from either side of the joint in order to level the surface.
